## **Private Lands Riparian Habitat Restoration Initiative**

**A project of the De-Go-La Resource Conservation and  
Development Project, Inc.**

# **Private Lands Riparian Habitat Restoration Initiative**

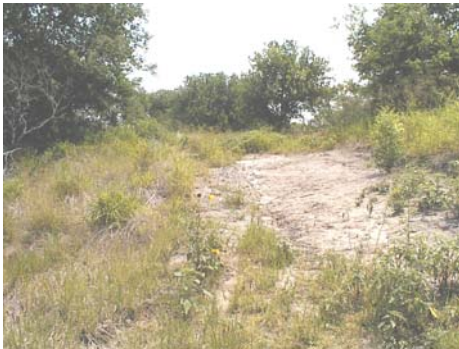
Prior to Restoration, this area had no vegetation and was eroding severely.

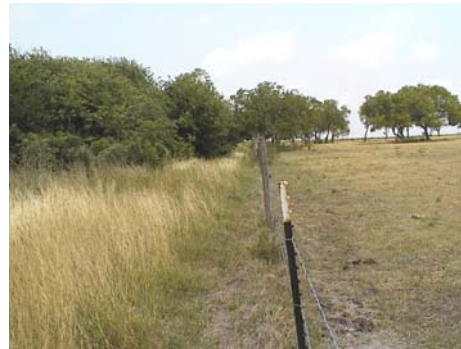
Fence construction and exclusion of livestock allowed the riparian area (on left) to re-vegetate.

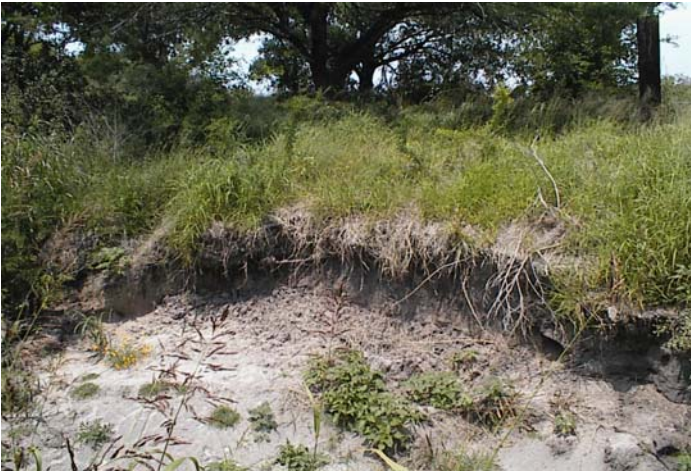
Prior to establishment of the riparian buffer, stream banks were subject to erosion by high velocity flows.

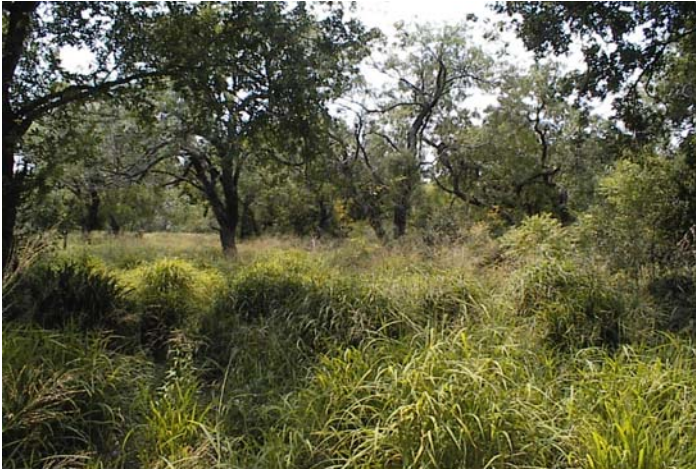
Reducing canopy cover and excluding livestock allowed herbaceous vegetation to establish on the site.

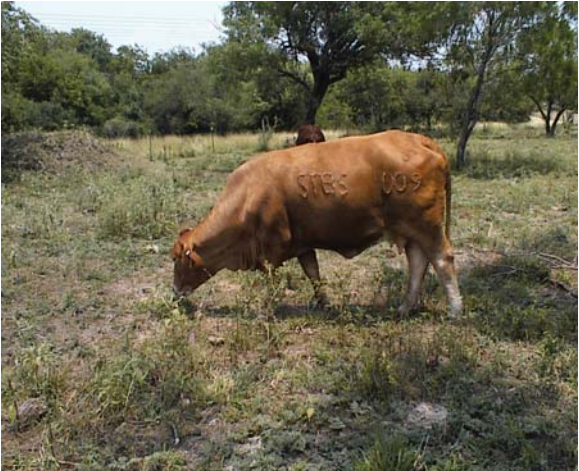
Livestock grazing on the site had been severe and resulted in areas devoid of herbaceous vegetation contributing to sediment and runoff.

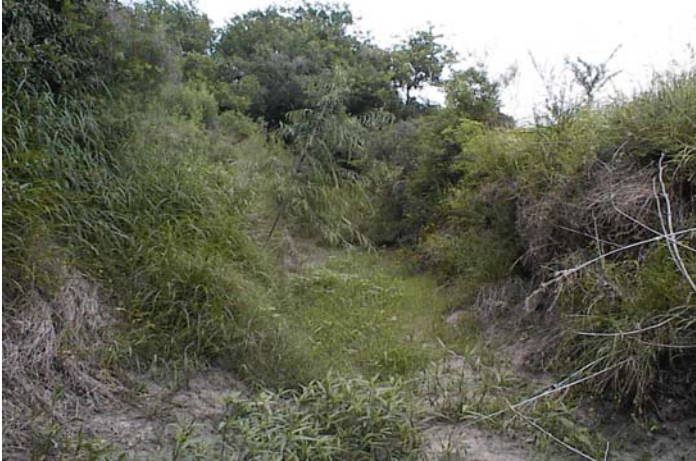
Damage to vegetation on stream banks by livestock was eliminated and vegetation was allowed to stabilize eroded areas.

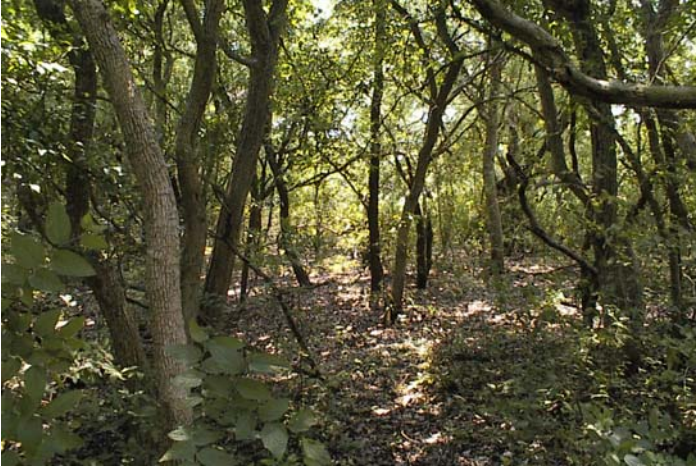
Prior to vegetative work to reduce the canopy, sunlight was unable to reach the ground resulting in little herbaceous cover.

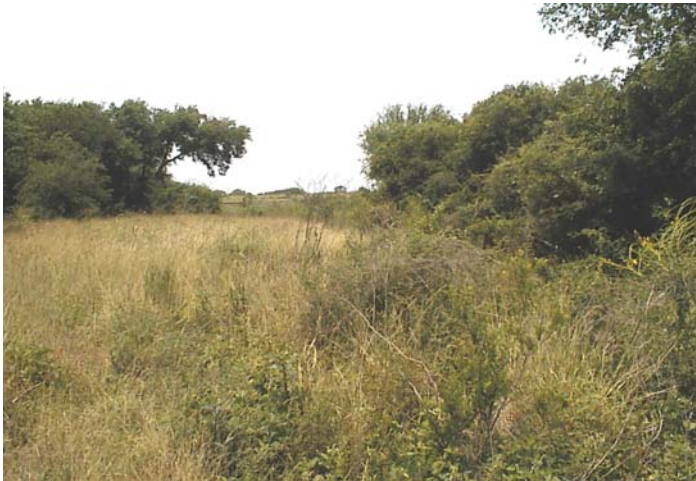
Open areas were created adjacent to stream (on right) resulting in vegetative diversity and improved edge effect for wildlife.

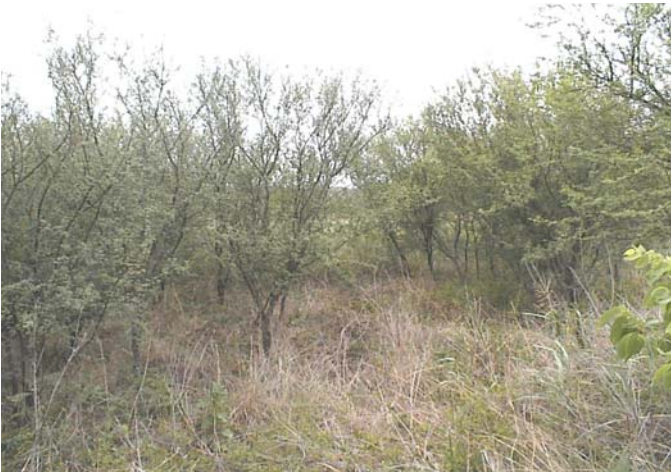
Prior to restoration work, this site was dominated by a very thick overstory of huiache brush

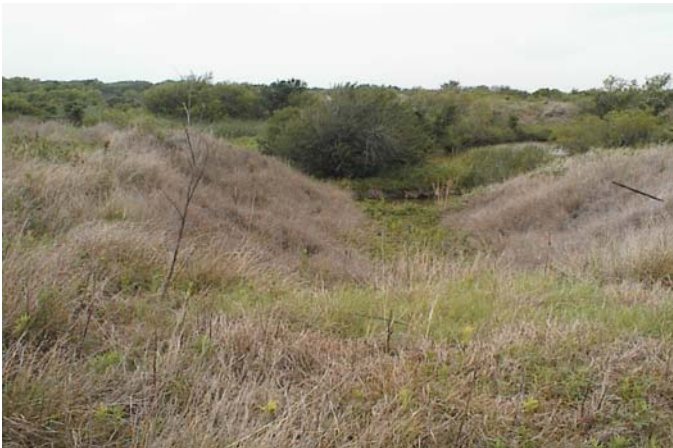
Runoff from adjacent cropland was directed into stable outlets to aid in filtering out sediment and pesticides.

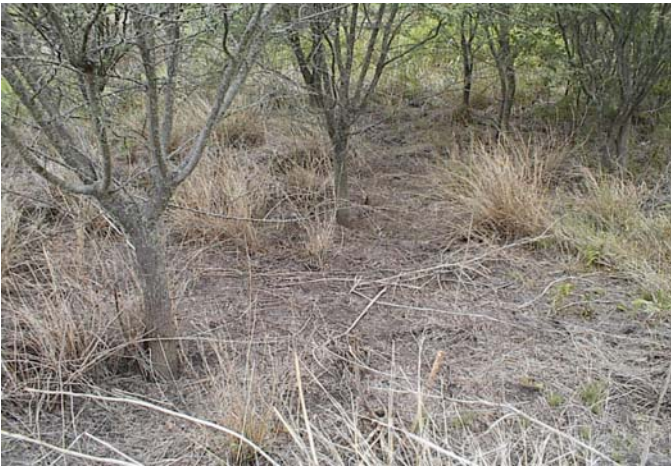
Bare ground and undesirable annual vegetation under the huiache failed to provide erosion control and diversity in wildlife habitat.

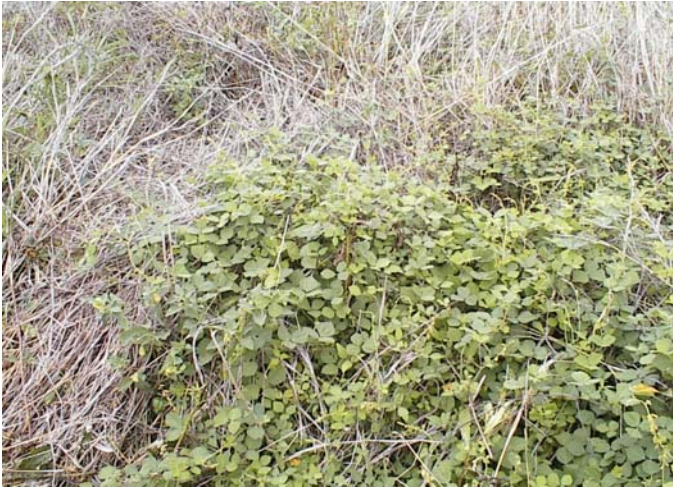
With removal of huiache, desirable species for wildlife such as least snoutbean reappeared on the site.

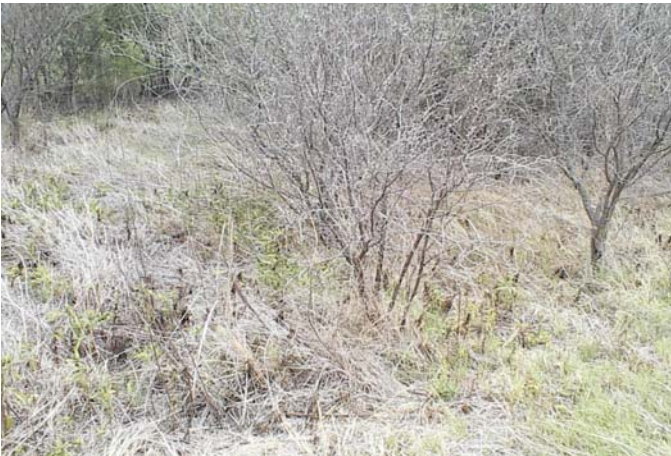
Where feasible, individual plant treatment with herbicide was used to kill huiache in place reducing soil disturbance by equipment.

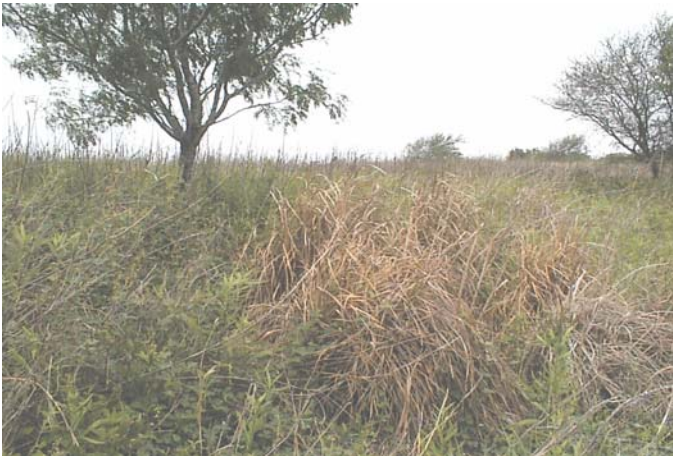
Tall grasses important to ground nesting birds were able to reestablish on the site following removal of undesirable woody canopy.

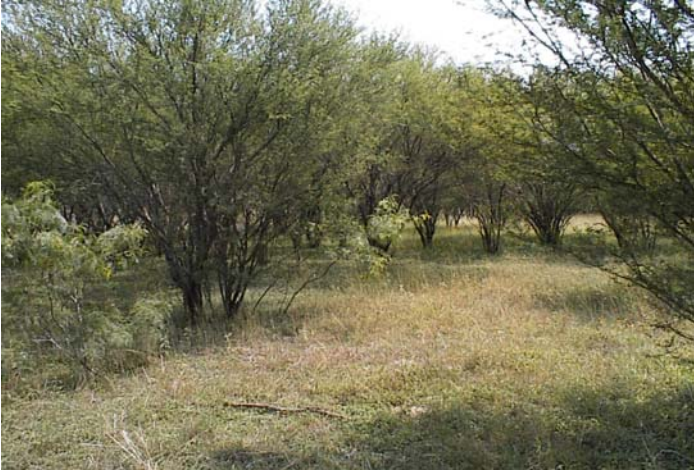
A thick community of huisache dominated the site prior to enrollment. This limited sunlight and water availability for herbaceous vegetation

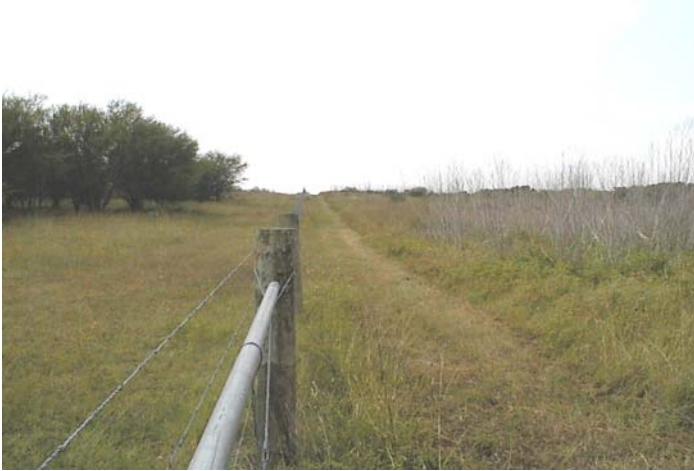
A barbed wire fence was constructed to exclude livestock from the riparian area (on right).

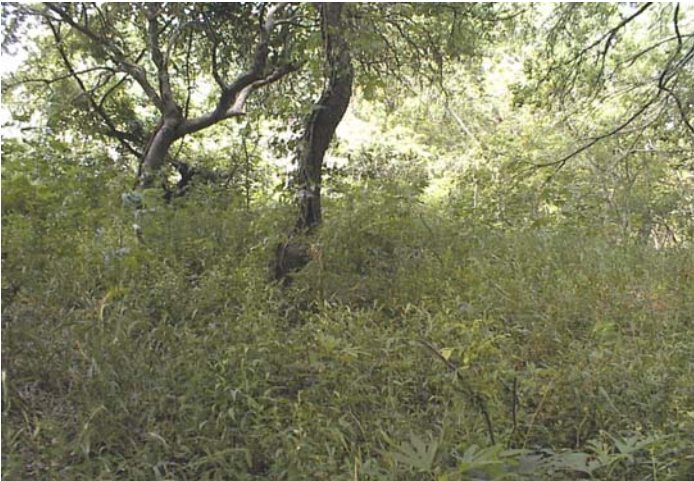
There was good variability in native woody overstory adjacent to the stream with elm, ash, and hackberry.

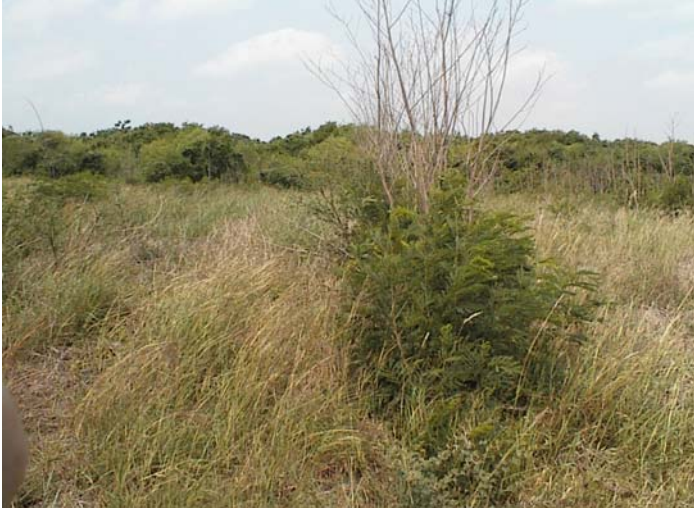
Rows of Luceina (foreground) were planted at selected points in the site to provide high quality browse for deer.

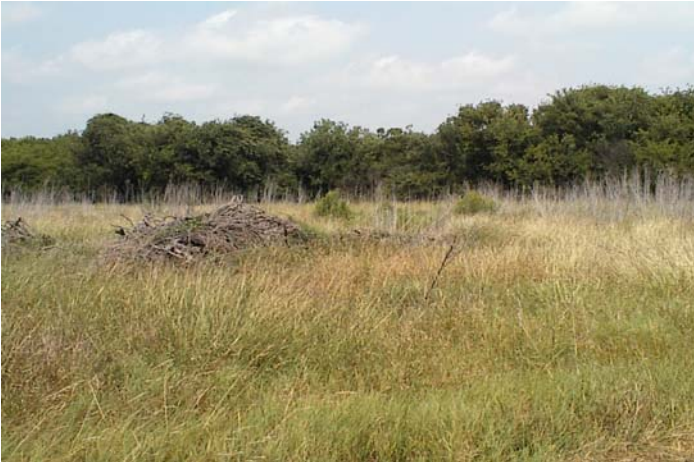
Undesirable huisache brush was mechanically removed to leave a wooded corridor (background) along the stream.

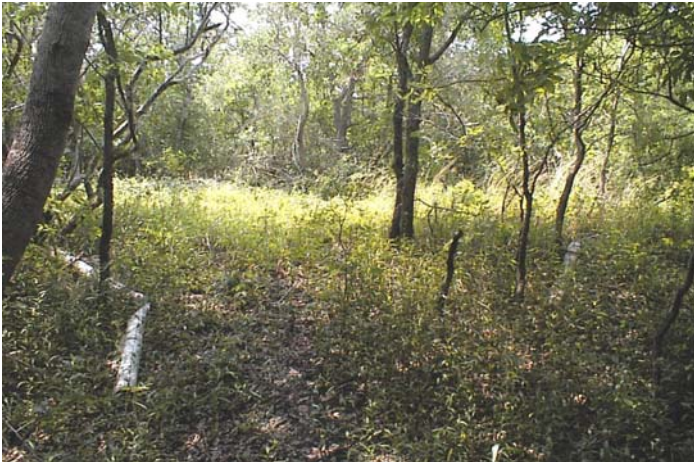
Protected woody stream corridors provide shade for cooling water, wildlife habitat, and filtering effect for sediment reduction and water quality.

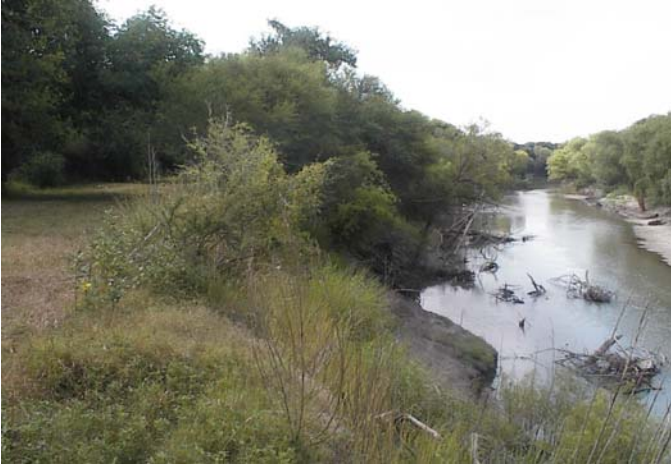
Prior to restoration work, many sections of the river bank were nearly vertical and subject to sloughing

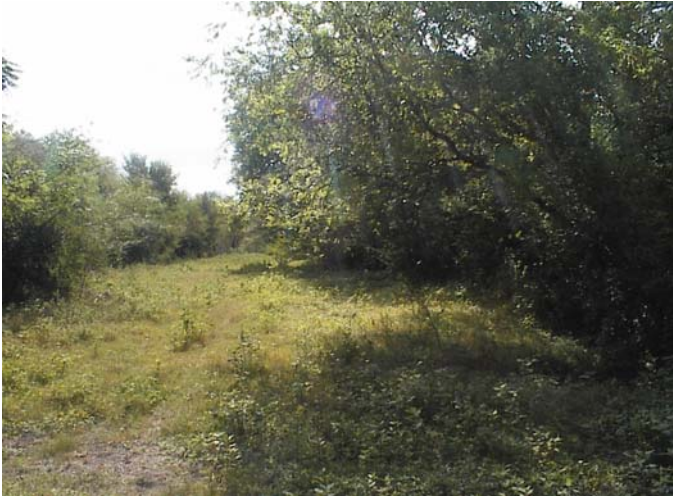
In some areas follow-up control with herbicides was needed to control re-growth brush and weeds.

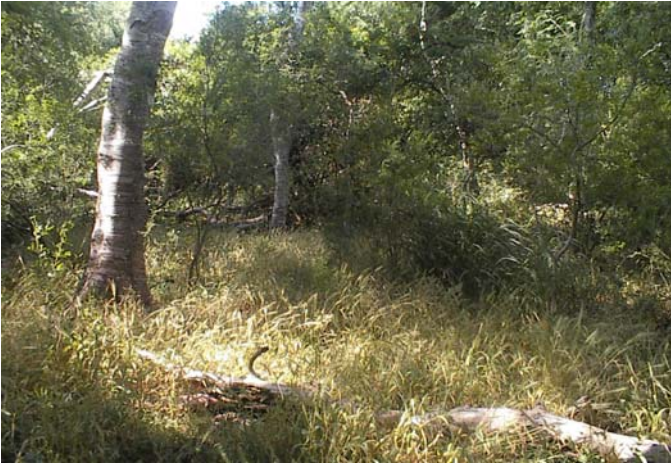
In many areas, undesirable woody species formed a dense canopy restricting sunlight from reaching the ground.

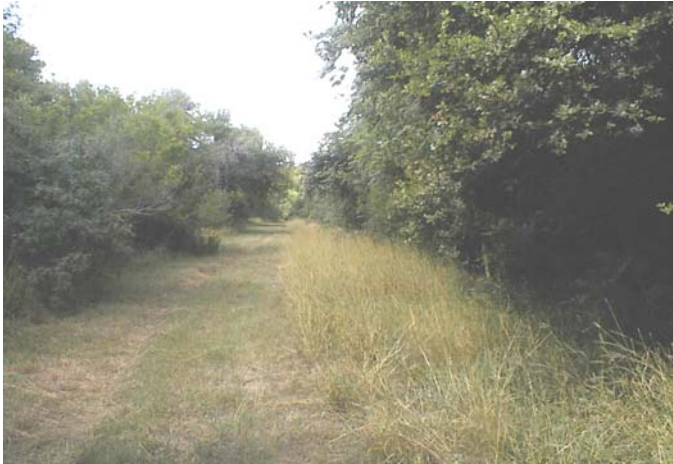
Perennial vegetation of grasses and forbs provided diversity of habitat for wildlife species including, songbird, turkey, and deer.

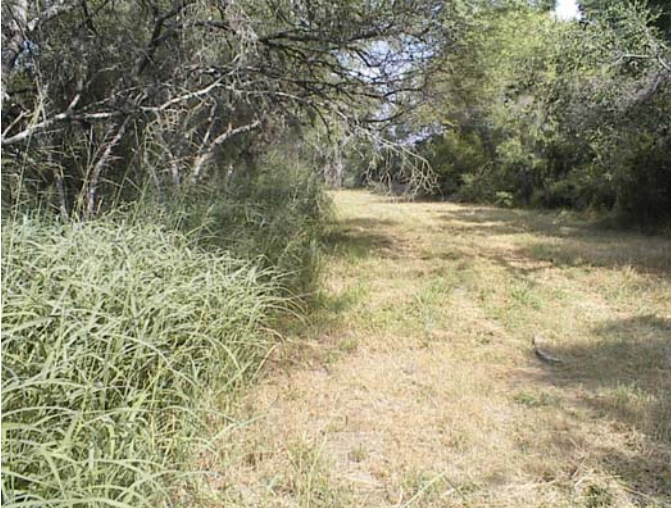
A wooded buffer area 35 feet wide was left along the river bank (left) and canopy was removed to allow herbaceous vegetation to grow.

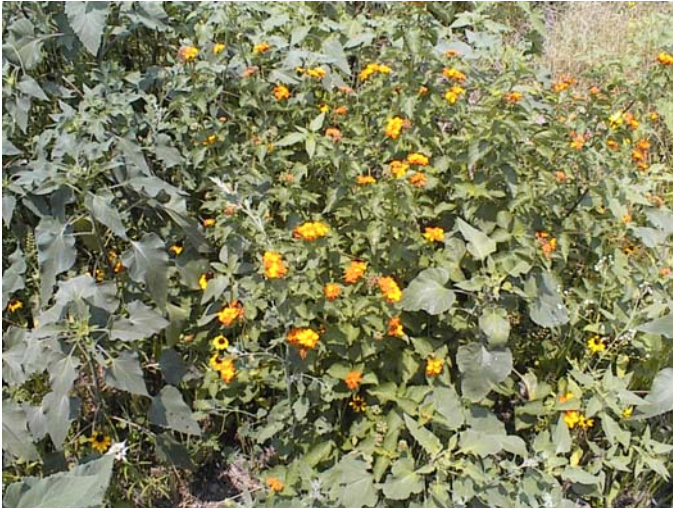
Higher quality habitat was achieved in addition to controlling stream bank erosion.

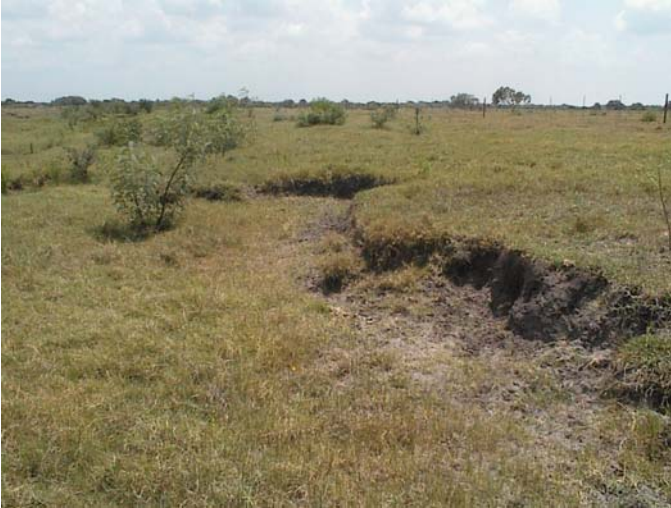
Trailing and over-grazing in the area created scour erosion on the banks and channel of the stream.

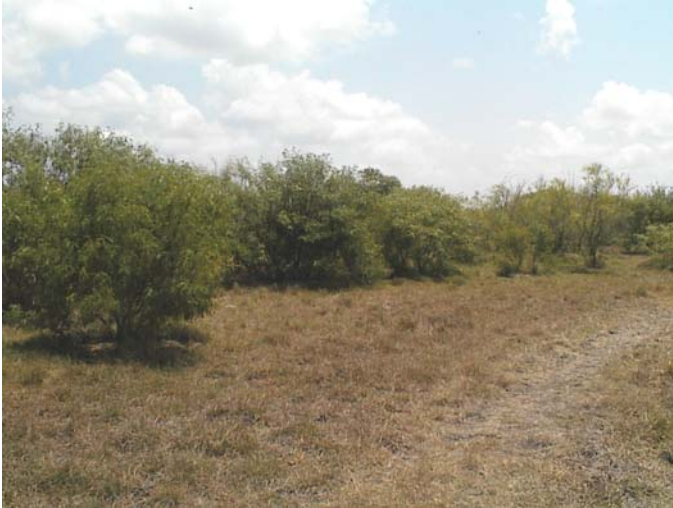
Overgrazing by livestock and infestation of undesirable wood vegetation lowered the value of habitat.

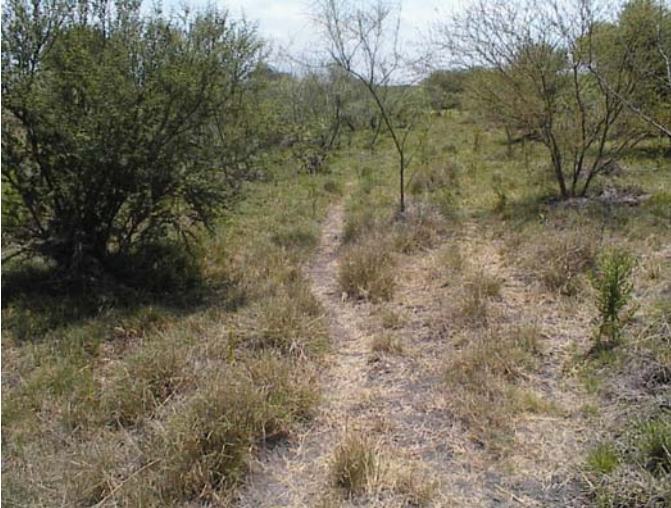
Livestock trampling and trailing in the area created bare soil subject to erosion.

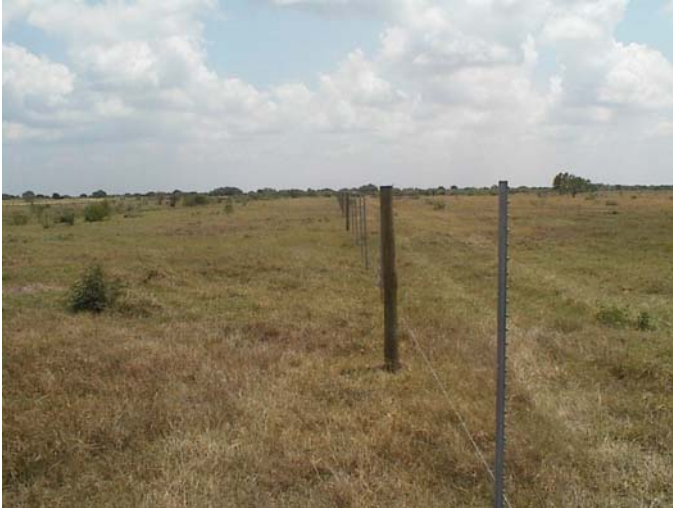
A fence was constructed to allow exclusion of livestock from the site (left).

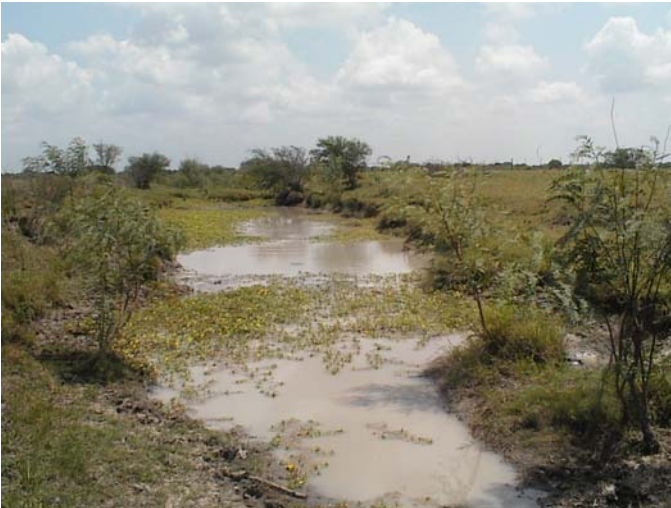
The site was the only source of livestock water available and this caused overuse.

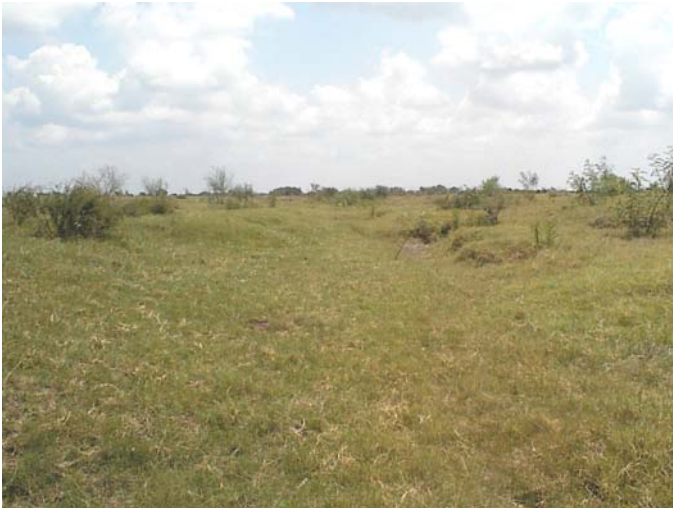
Following exclusion of livestock and removal of brush, previously bare areas were re-vegetated.
